HCI Howard Consultants, Inc.

July 12, 1991

Project No. 3218-10

Re: Soil Contamination Assessment
Conoco
Plummer, Idaho

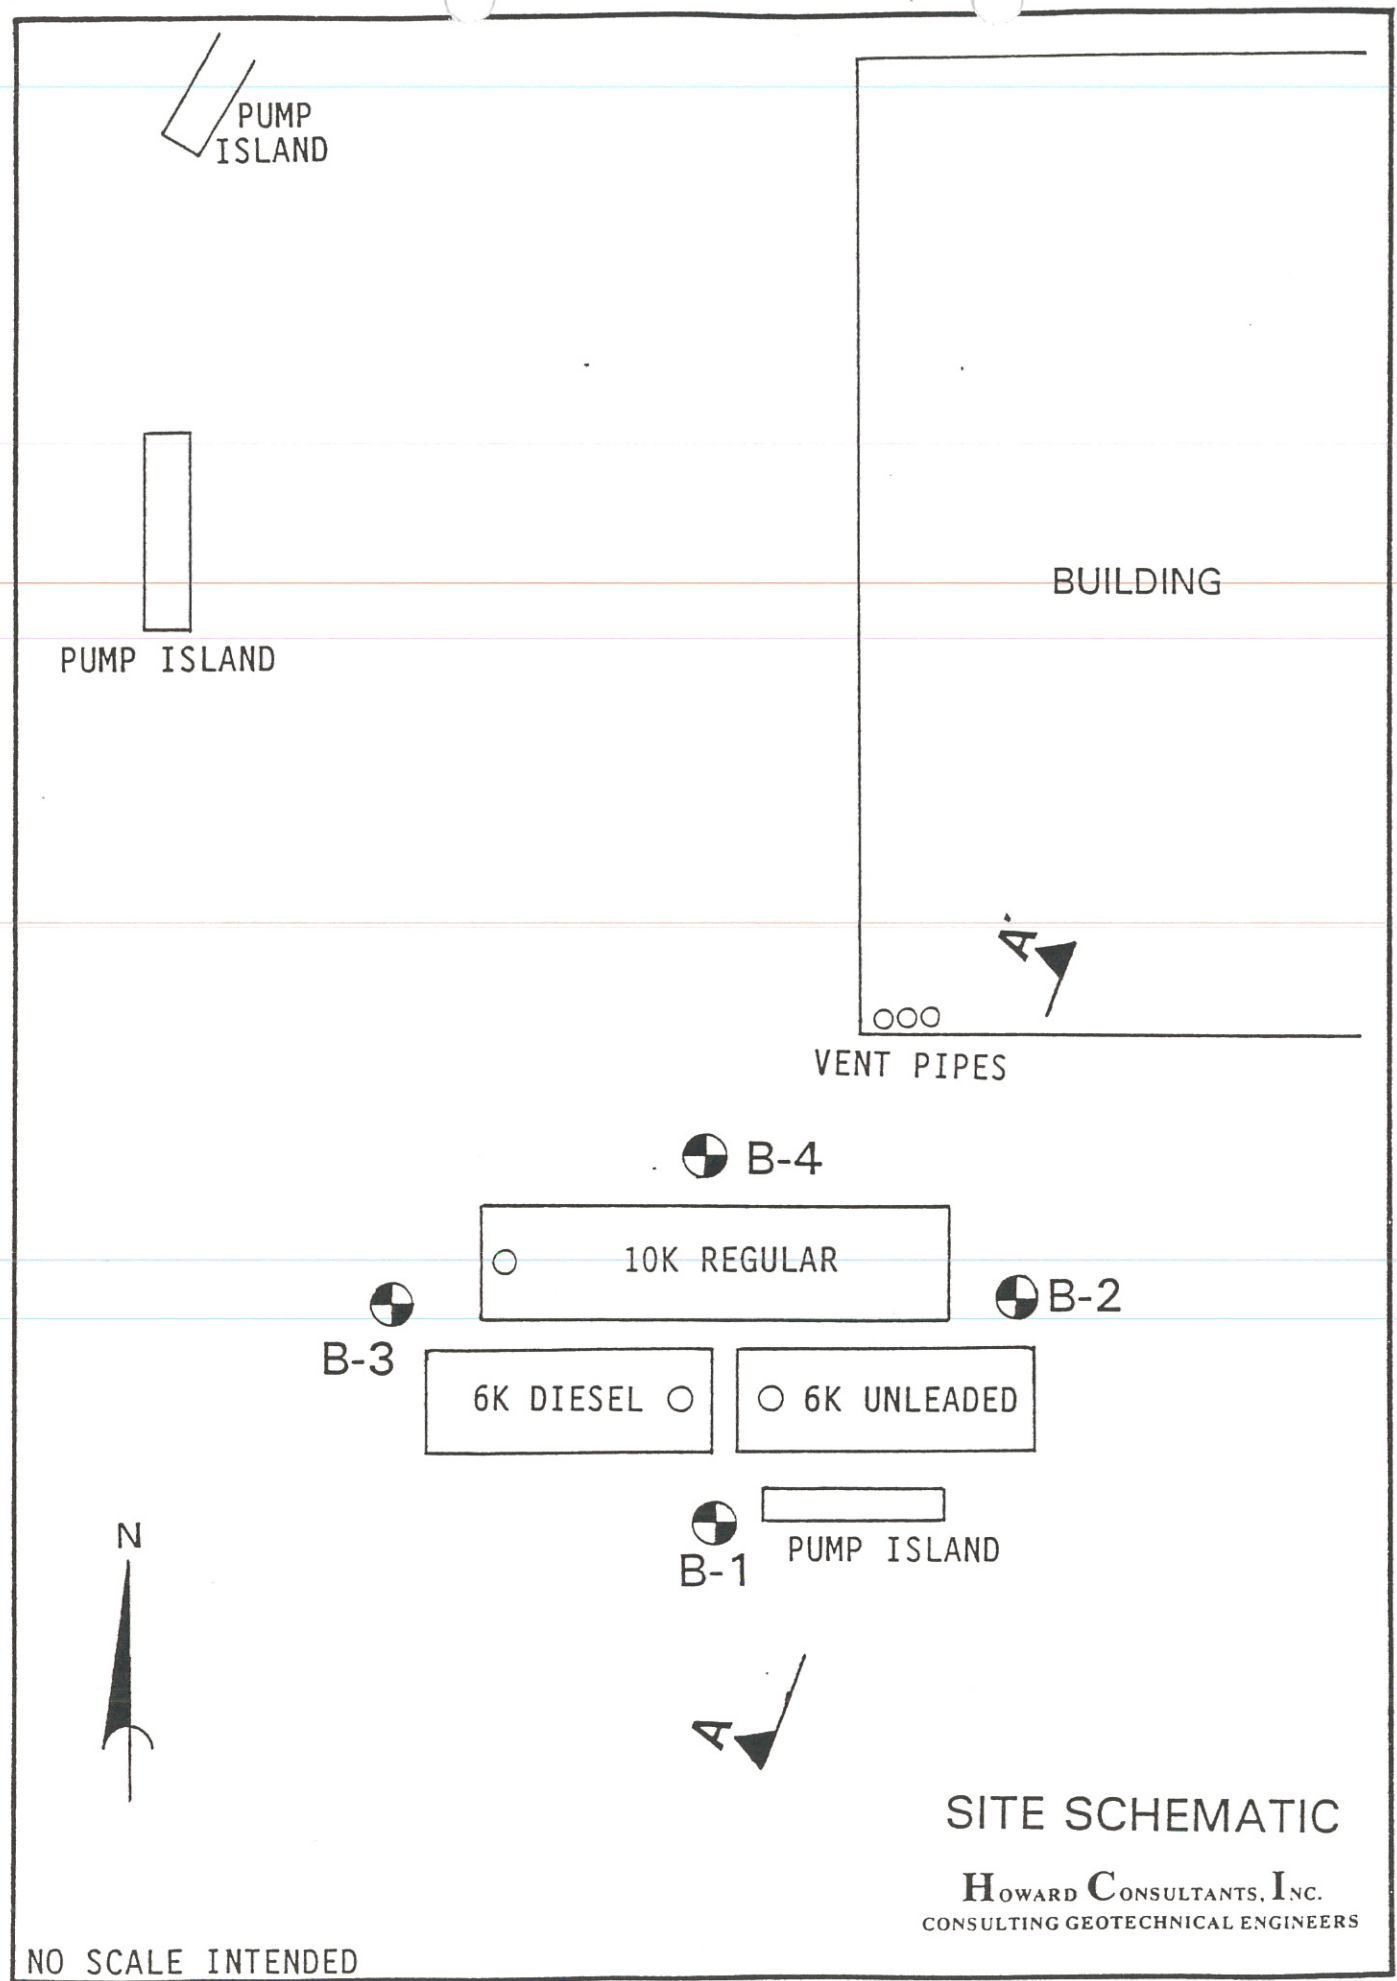
SITE SCHEMATIC

It is our understanding that three gasoline storage tanks were buried in a common excavation on the site. The tanks were two 6,000 gallon tanks and one 10,000 tank holding unleaded, diesel and regular gasoline respectively. The tanks were installed approximately eight years ago. We understand the tanks were eight feet in diameter and were buried approximately six feet below the ground surface. The tank excavation was backfilled with native material. The locations of the vent pipes, electrical lines and pump feeder lines were inferred from the position of the tanks to the pump islands. Plate 1 presents a site schematic of the property.

Four soil test borings were drilled on June 18, 1991. The borings were augered by Ruen Core Drilling with a mobile B-50 drill rig to a depth of approximately twenty feet. Soils samples were taken at 5, 10, 15, and 20 foot depths in each boring. The approximate locations of the borings are shown on Plate 1 Site Schematic.

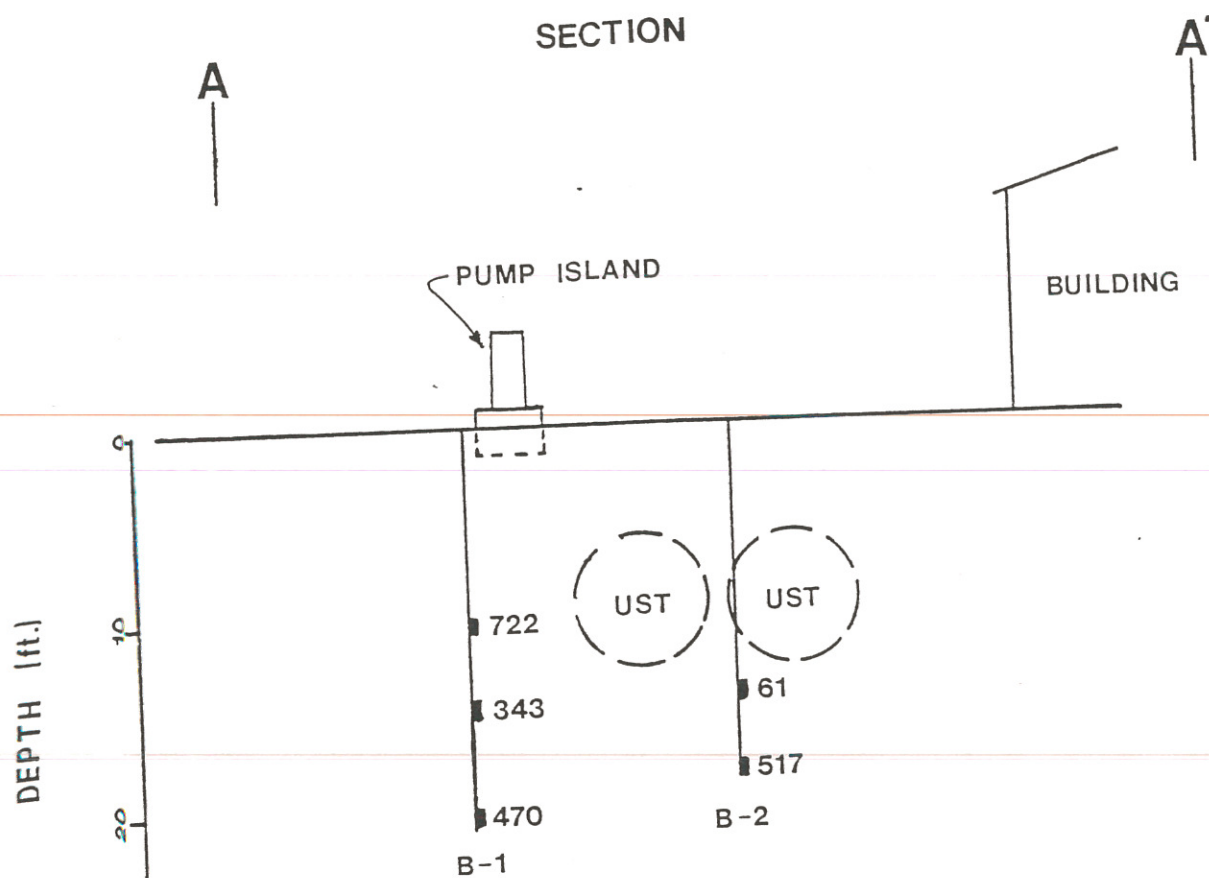
PLATE 3

Based on the soil analyses and known history of the site, it is our opinion that relatively low to moderate levels of contamination exist at the site. The highest concentrations were detected within the soils encountered in B-1 and B-2. Lower concentrations were measured in B-3 and B-4. A section presented on Plate 3 shows a schematic interpretation of the contamination on the site.

Although the samples we recovered did not have residual TPH levels which require clean-up by current IDEQ Standards, contamination was detected at depths of 20 feet below the ground surface and approximately 15 feet from the pump island. The 722 ppm encountered in B-1 is approaching unacceptable TPH levels. The contamination may be the result of the damaged fitting but we recommend that tank tightness testing be performed to verify the integrity of the tank and pipe system.
